CASE STUDY

Centek S2

YURALPA, ECUADOR

CUSTOMER ENCOUNTERS CASING RUNNING PROBLEMS AND RE-RUNS THE SAME CENTEK CENTRALIZERS ON THE SECOND TRIP DOWN

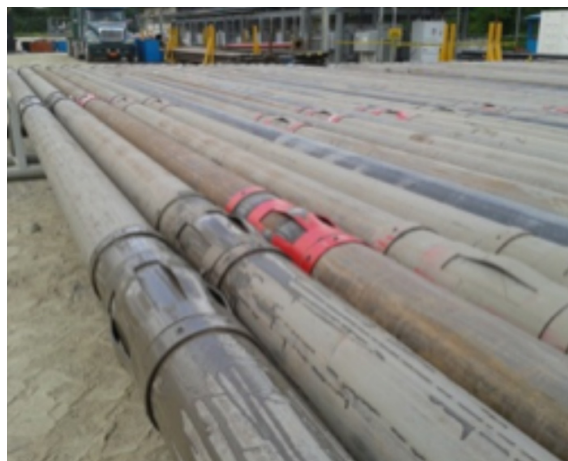
All Centek centralizers and stop collars were recovered and inspected to be found in good condition. The stop rings had not moved and the centralizers were still in their original positions on the casing. There were areas where the powder coating had been removed, but there were no signs of bent bows or bent centralizers. After the clean out and well conditioning trip, the very same Centek centralizers and stop collars
