# WEST TURKEY

## CEN TEK ES CENTRALIZER TRIAL DEMONSTRATES SUPERIOR PERFORMANCE

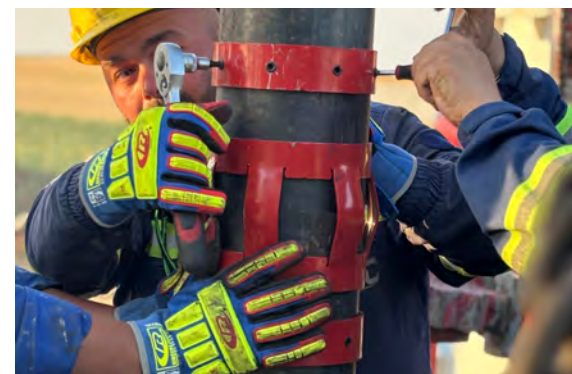
- The performance and benefits of Centek's ES and S2 centralizers
- Proper stop collar installation methods
- Optimized spacing and installation best practices

The installation at the rig was supported by translated instructions to ensure every procedural step was clearly understood and precisely followed. On-site, Centek representatives observed the process and verified that all recommendations were correctly implemented, making real-time adjustments where necessary to accommodate last-minute schematic changes.

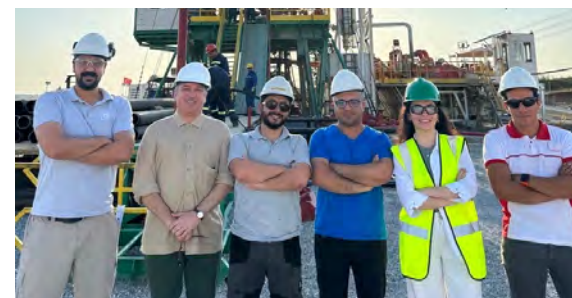
The operation was a fully collaborative effort between the operator, distributor, and Centek's technical specialists — with all teams working together to ensure flawless execution from design through to installation.

The casing run was smooth and executed exactly as planned. The two-stage cement job achieved excellent returns, with a clear separation between mud and cement at surface — an early indication that the centralizers delivered good standoff and held the casing in the center of the wellbore.
