CASE STUDY Centek S2 ONSHORE

PETROAMAZONAS, ECUADOR

SUCCESSFUL LINER RUNNING OPERATION AND RECIPROCATION ACHIEVED ON BOTTOM, ALLOWING EFFECTIVE CEMENT PLACEMENT ON THIS CRITICAL LINER JOB

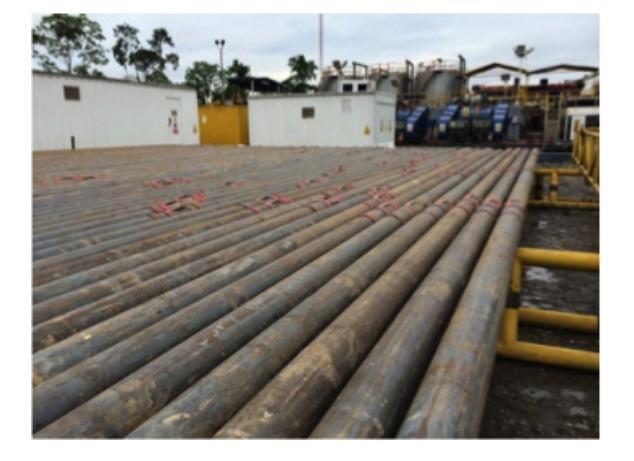
Halliburton proposed using the Centek S2 7" x 8 1/2" centralizers. These were chosen for their ruggedness and best selection for passing through the KOP exit window without problems (not once but twice!). Halliburton ICEM and Centek Latload modeling recommended locating two centralizers per joint mostly all along the open hole to give the best possible stand-off and chances of success with this cement job. Simulations showed that running the liner and achieving good cement sheath would be possible. Halliburton pumped an ElastiCem Wellife slurry on this job to provide optimal zonal isolation along productive life of the well, which has various pay zones.

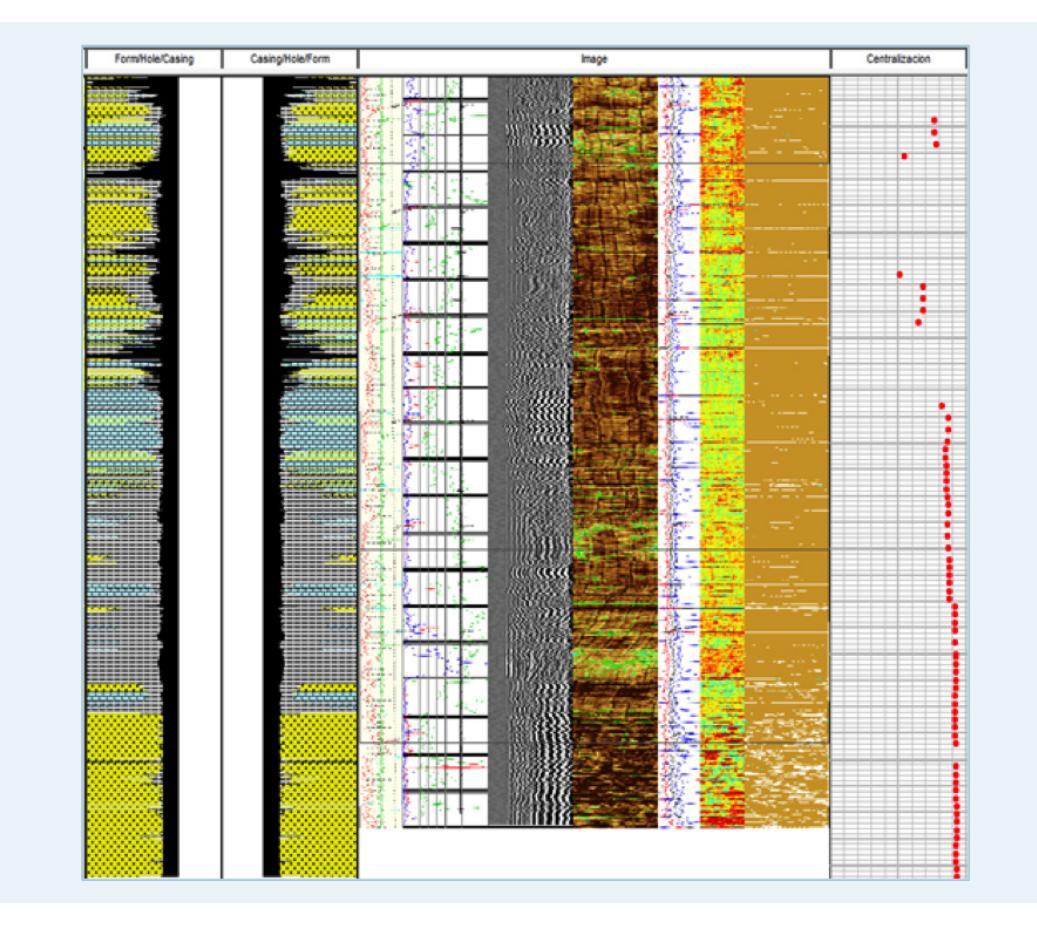
The production 7" liner reached TD without any problems. Due to torque limitations it was not possible to rotate the string when on bottom, but the Operator was able to reciprocate during circulation and cementing job. This allowed for good mud displacement efficiency and placement of cement all along and around the liner, despite the heterogeneous conditions of wellbore. This was reflected in the cement bond log.
