# HIGH PRESSURE, HIGH TEMPERATURE, NORWAY

RUNNING OVERSIZED CENTEK UROS CENTRALIZERS IMPROVED STAND-OFF IN WASHED OUT HOLE SECTIONS OF HPHT WELL

<b>Region:</b>	Europe
<b>Location:</b>	Northern North Sea

<b>Country:</b>	Norway
<b>Field:</b>	Gullfaks Sor

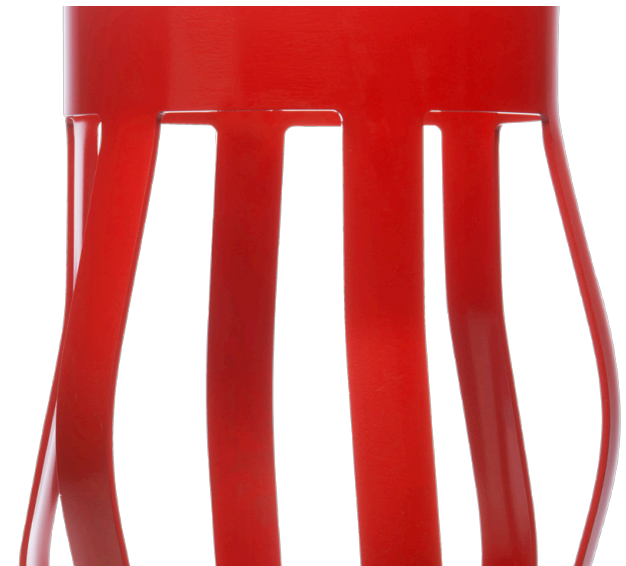
Centek and Halliburton recommended the UROS centralizer in an over gauge casing by open hole design combination over the originally drilled open hole size. For the challenges this well presented, it was suggested to run 7 x 9 1/2".

- Single piece construction with offset bows
- Proven tool for deep water
- Dramatically reduced initial insertion forces into previous casing
- Reduces restart force on RIH
- Reduced running force and drag, saves rig time on RIH
- Positive location in under-reamed or wash out conditions with excellent stand-off performance

The UROS offers the same high performance value as the Centek S2, but with additional benefits. Due to the UROS's unique off set bow profile, it can fit through tighter restrictions easier due to lower starting forces whilst still providing optimum performance for the hole size it is designed for. This is an advantage of this feature in washed out holes.

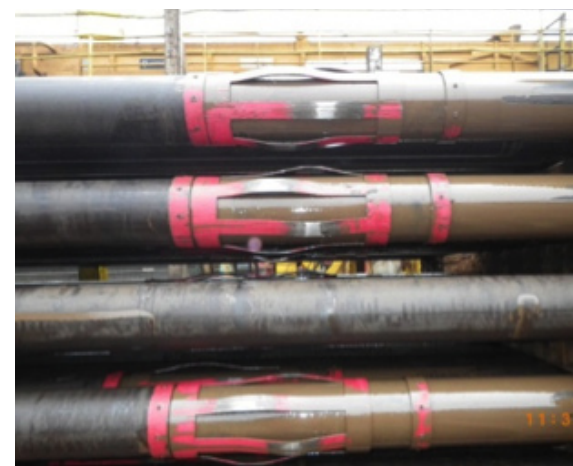
rotated in the cased hole section at 20rpm's for approximately 12 hours. Once out of the hole, the centralizers were inspected and it was decided that they were in proper condition to be run again. The centralizers showed some signs of point contact wear, some powder coated paint finish was missing, and some set screw sockets on the limit clamps were bent in, but overall they were still able to perform as originally intended.

The Centek stop collars were in their original positions and were in condition to be re-run. The unique Centek high performance, non-welded, bow spring design, enables this re-run situation to take place more times than when typical slip on and hinged welded bow spring designs are utilized. The Centek stop collars are of the same non-welded Centek design and are heat treated for increased integrity and ruggedness.

The 7" liner was re-run and reached TD without any problems. The centralizers had been run 35,351ft on an 11,811ft wellbore design and had gone through an exit window twice and had seen rotation for over 20 plus hours with no damage to the centralizers. The cementing job on the liner was performed as per design.
