# HIGH PRESSURE, HIGH TEMPERATURE, NORWAY

RUNNING OVERSIZED CENTEK UROS CENTRALIZERS IMPROVED STAND-OFF IN WASHED OUT HOLE SECTIONS OF HPHT WELL

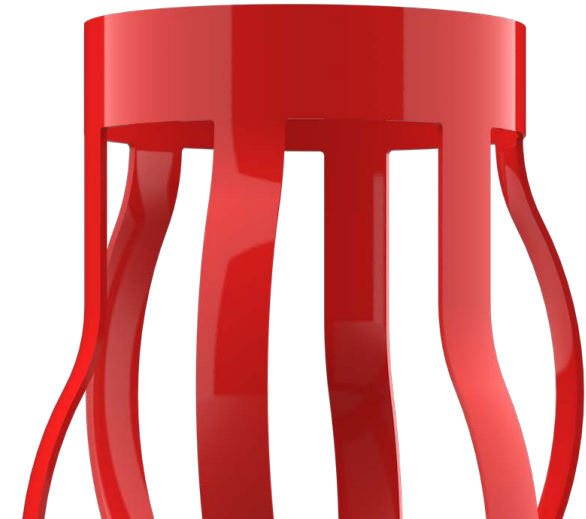
## UROS Award Winning Innovation

- Single piece construction with offset bows
- Proven tool for deep water
- Dramatically reduced initial insertion forces into previous casing
- Reduces restart force on RIH
- Reduced running force and drag, saves rig time on RIH
- Positive location in under-reamed or wash out conditions with excellent
- stand-off performance

The UROS offers the same high performance value as the Centek S2, but with additional benefits. Due to the UROS's unique off set bow profile, it can fit through tighter restrictions easier due to lower starting forces whilst still providing optimum performance for the hole size it is designed for. This is an advantage of this feature in washed out holes.

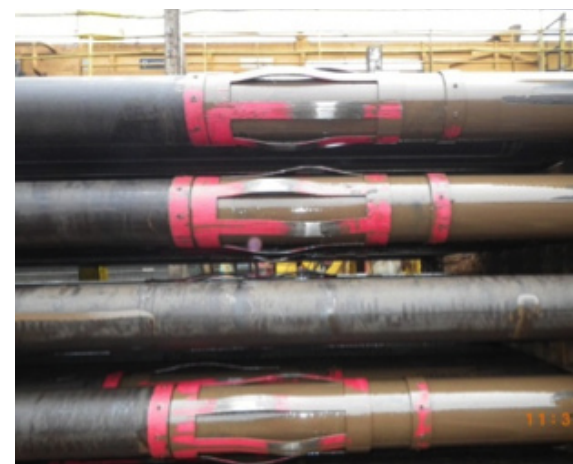
rotated in the cased hole section at 20rpm's for approximately 12 hours. Once out of the hole, the centralizers were inspected and it was decided that they were in proper condition to be run again. The centralizers showed some signs of point contact wear, some powder coated paint finish was missing, and some set screw sockets on the limit clamps were bent in, but overall they were still able to perform as originally intended.

The Centek stop collars were in their original positions and were in condition to be re-run. The unique Centek high performance, non-welded, bow spring design, enables this re-run situation to take place more times than when typical slip on and hinged welded bow spring designs are utilized. The Centek stop collars are of the same non-welded Centek design and are heat treated for increased integrity and ruggedness.

The 7" liner was re-run and reached TD without any problems. The centralizers had been run 35,351ft on an 11,811ft wellbore design and had gone through an exit window twice and had seen rotation for over 20 plus hours with no damage to the centralizers. The cementing job on the liner was performed as per design.
